**AES PUERTO RICO, L.P.
Guayama, Puerto Rico**

**July 21, 2017 Site Visit
& Proposed Enforcement
Strategy**

**José A. Rivera BSCF
Lead Environmental Engineer
CEPD Clean Water Act Team**

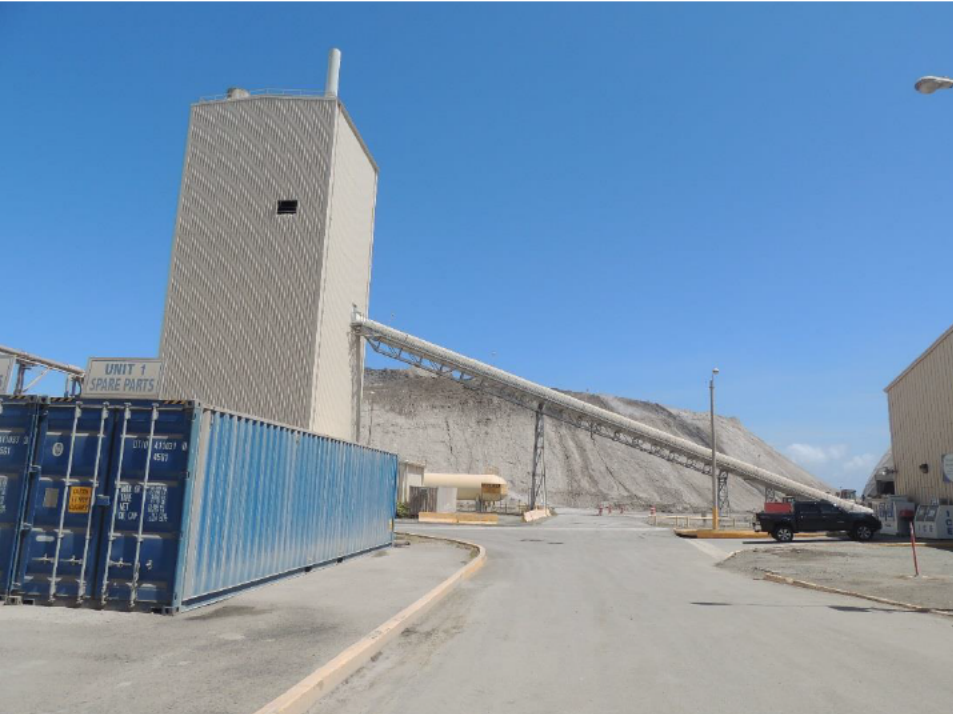
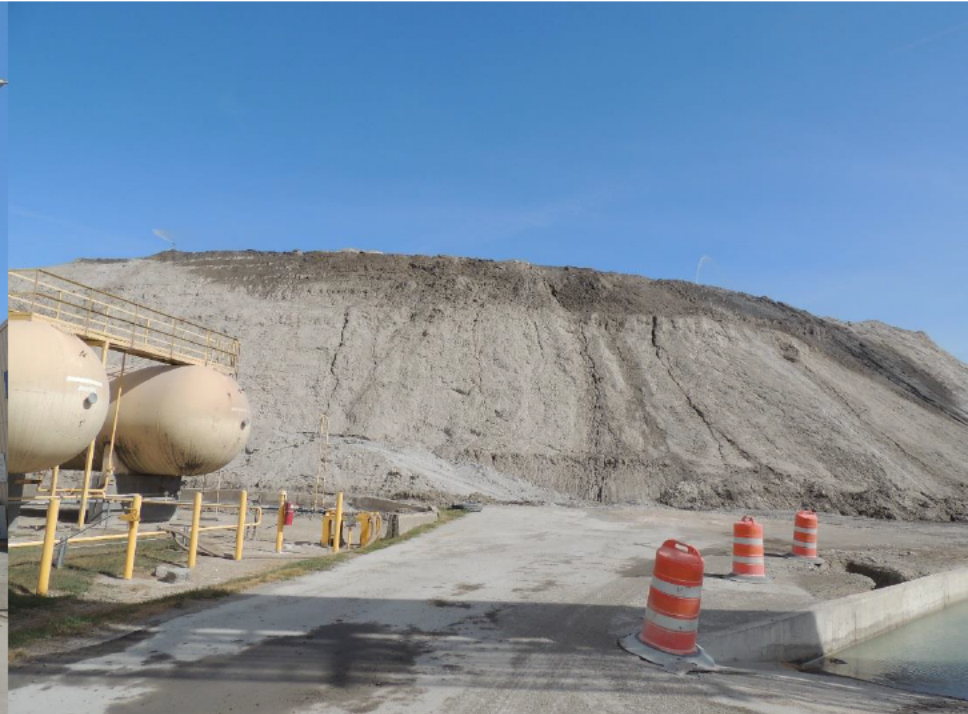
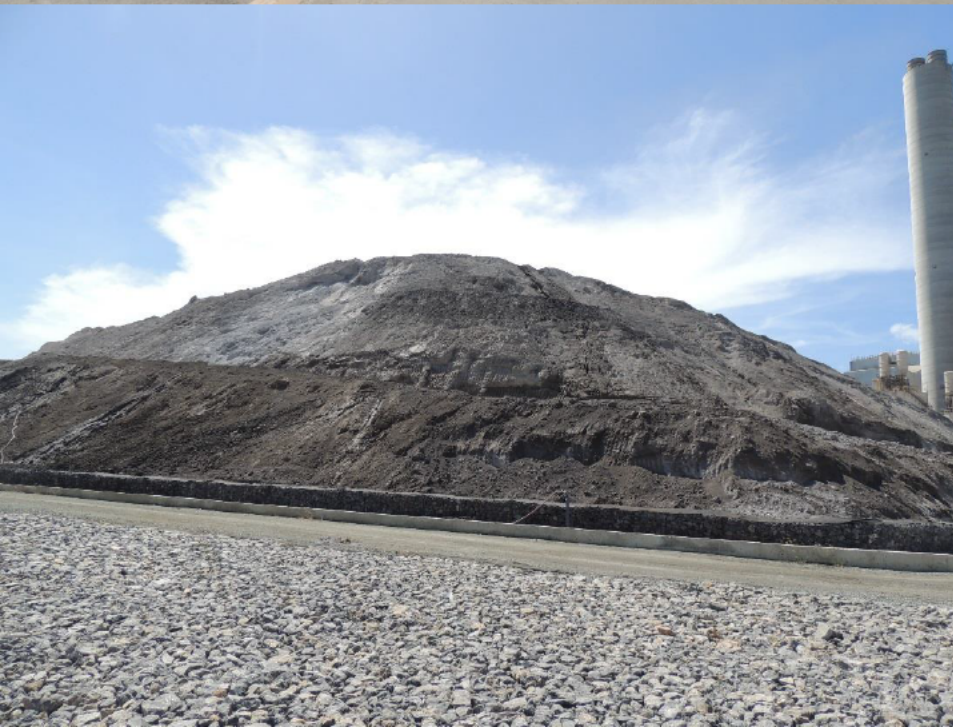
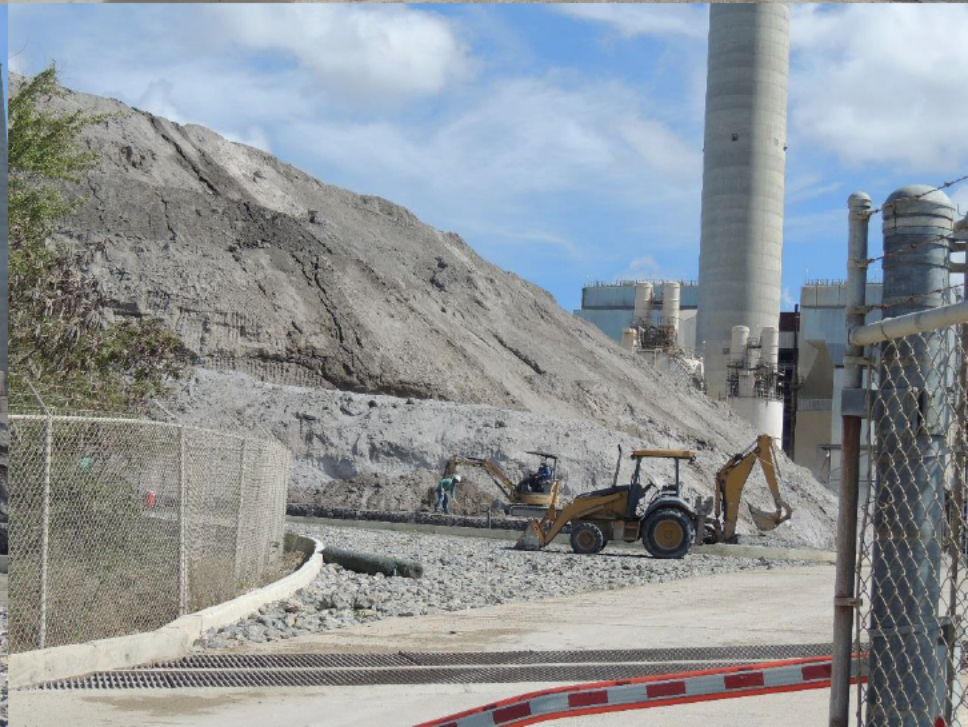
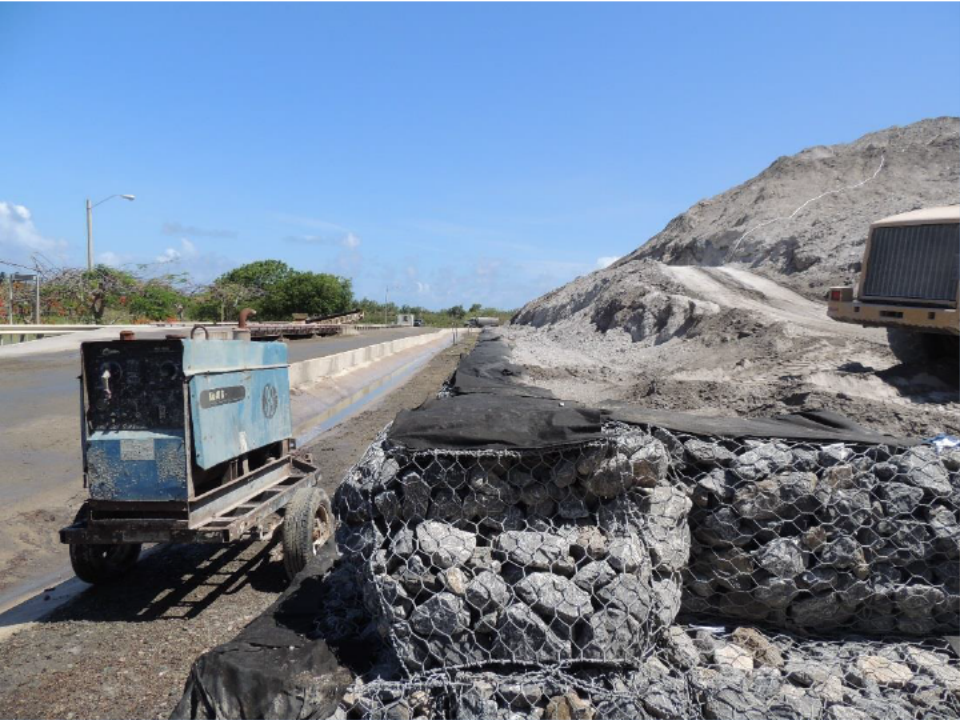
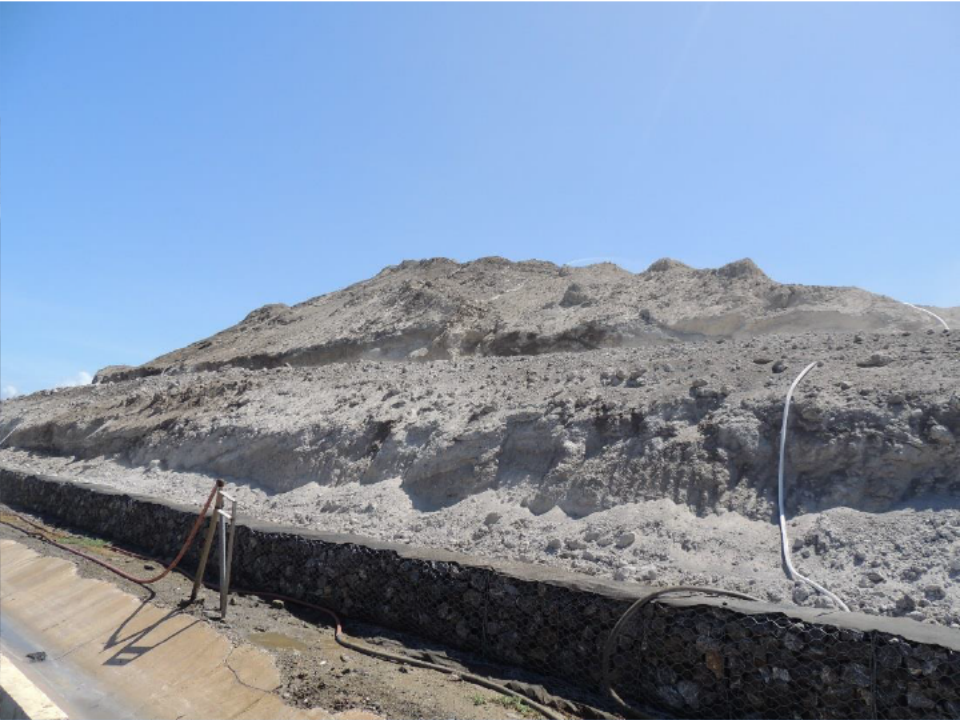
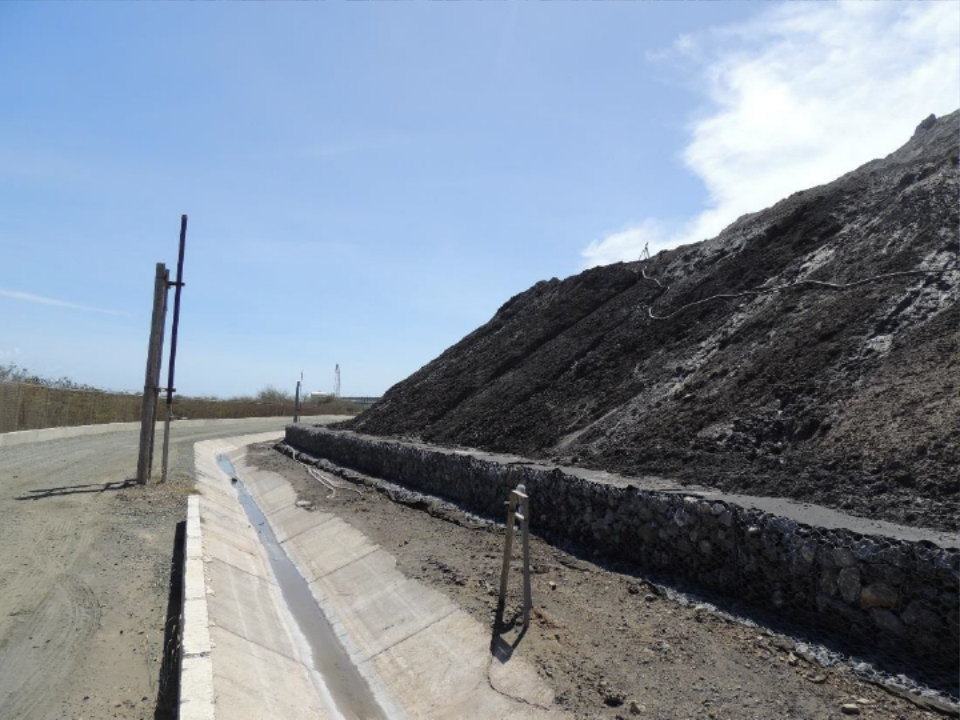
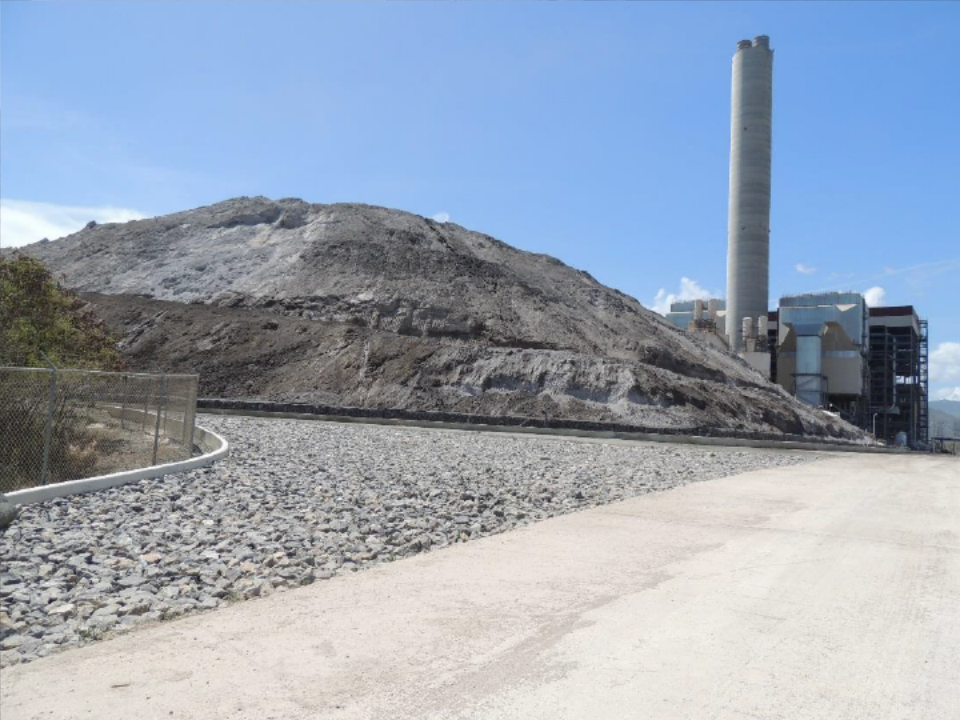
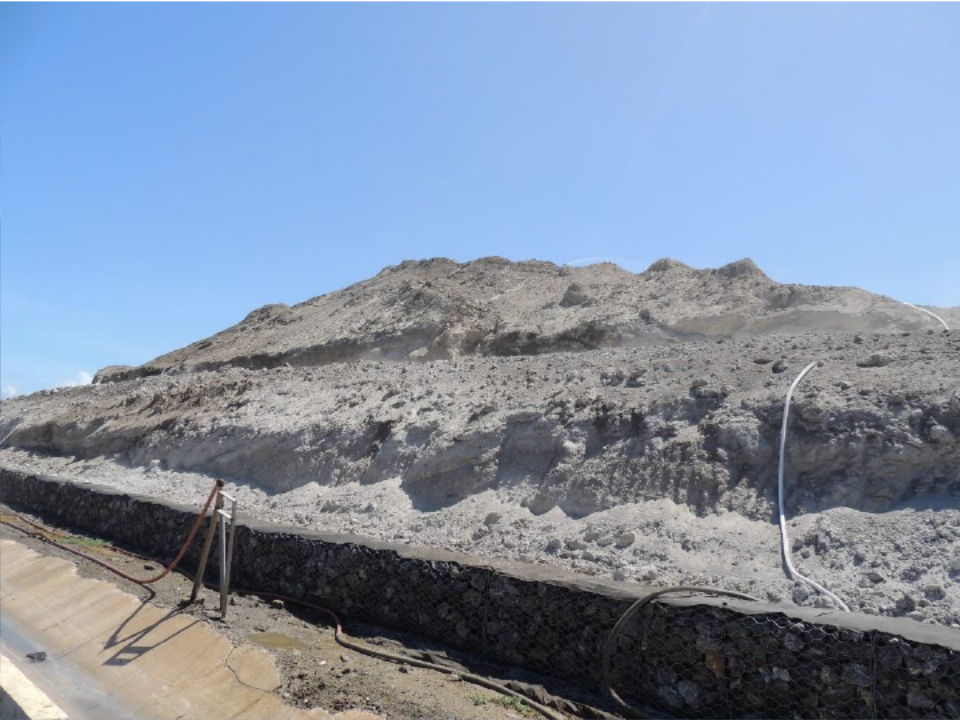
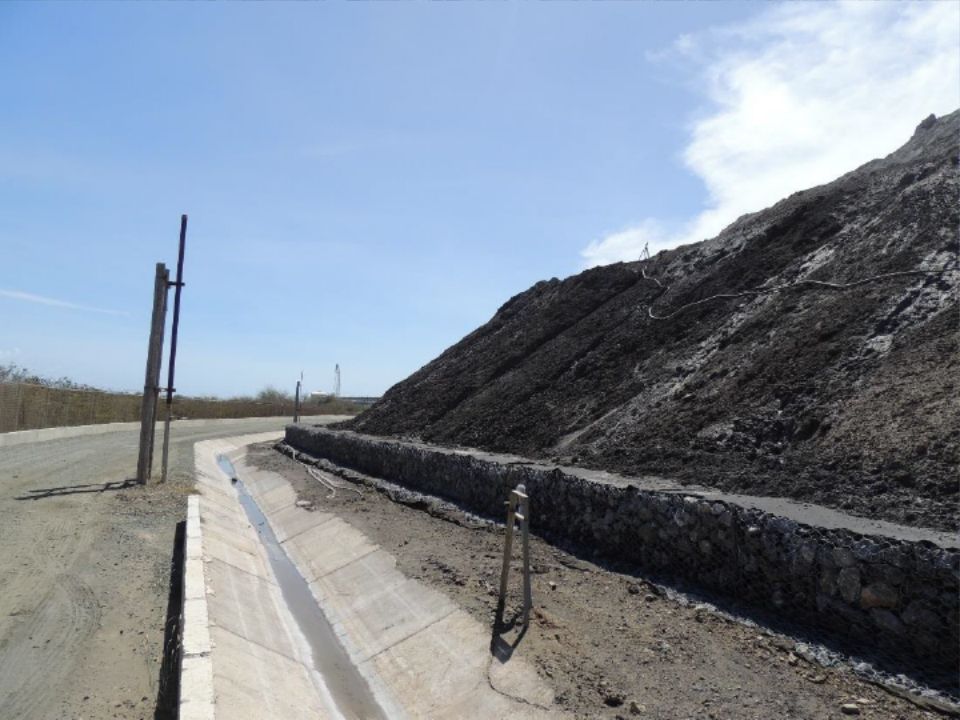
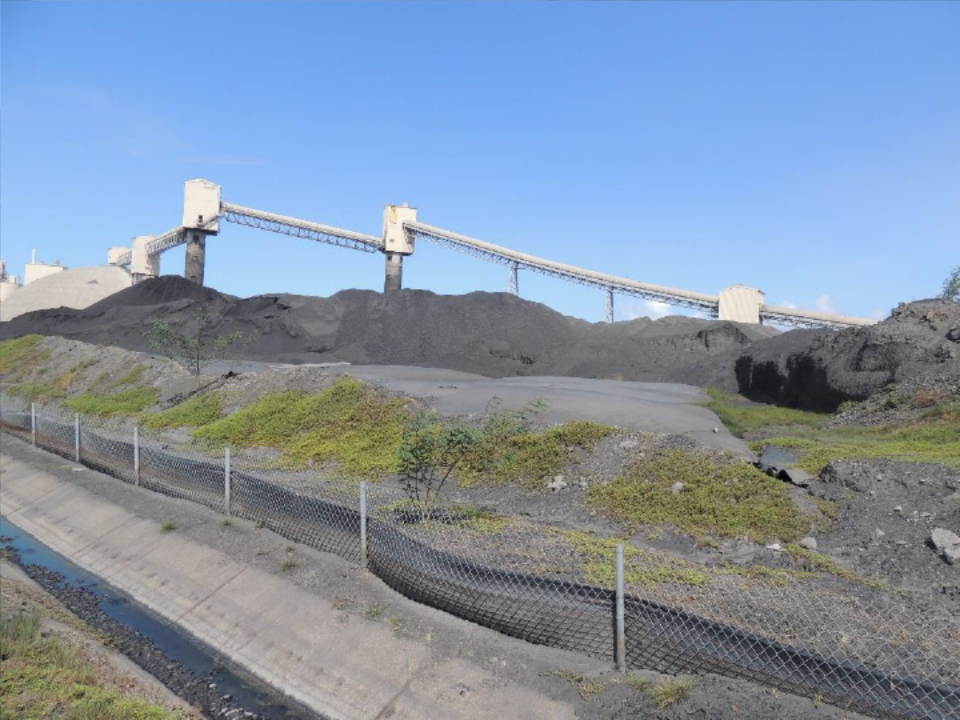
- May 2013
 - EPA approved 31 Structural BMPs and 55 Non-Structural BMPs
 - AES constructed 2 additional BMPs.
- August 2013 – EPA inspected BMPs construction activities
- September 2013 - Construction Substantial Completion
- September 2013 - 2008 MSGP coverage obtained
- June 2014 – Inspection
- December 2014 - Inspection

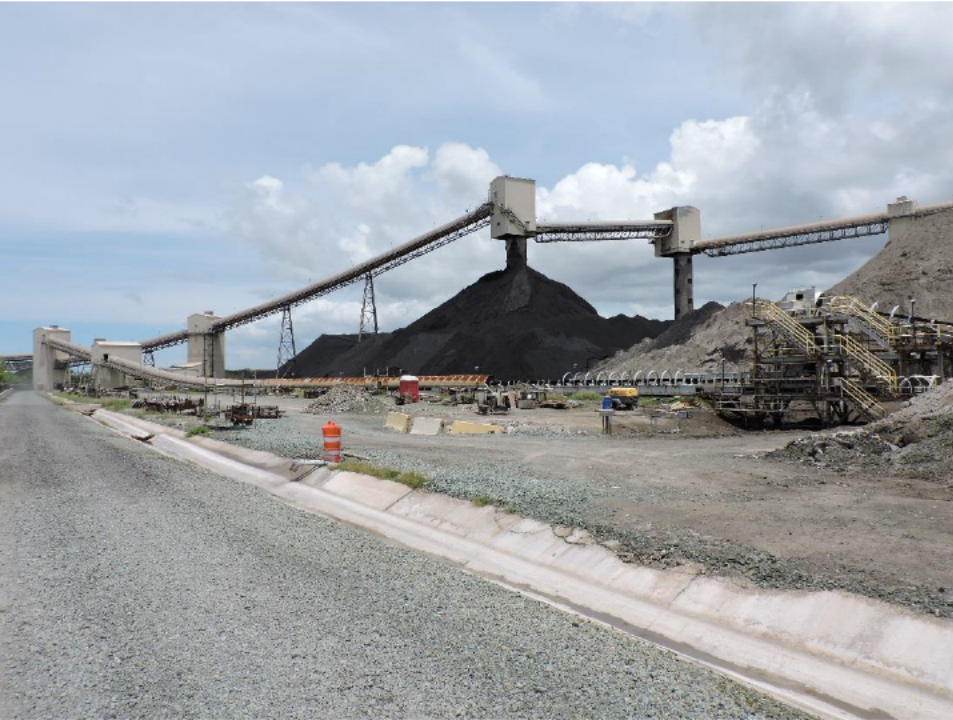
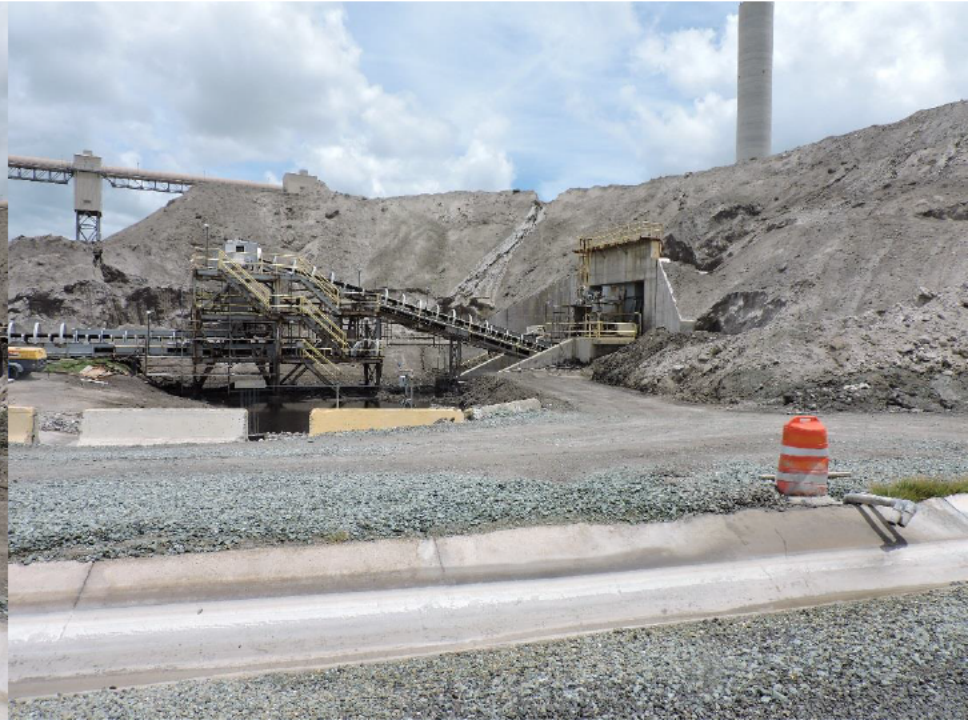
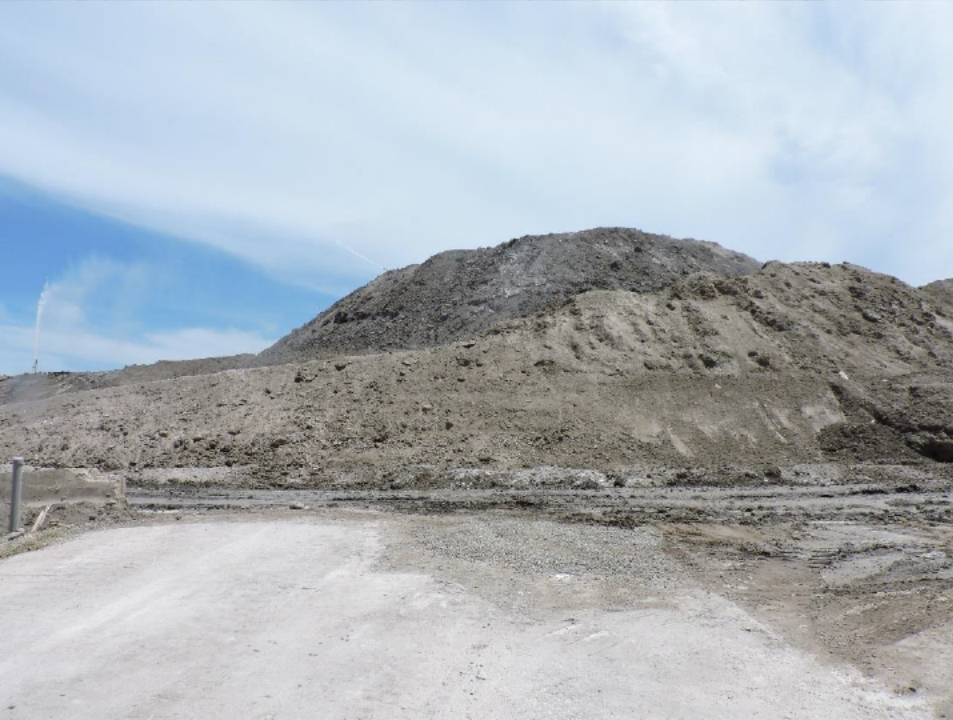
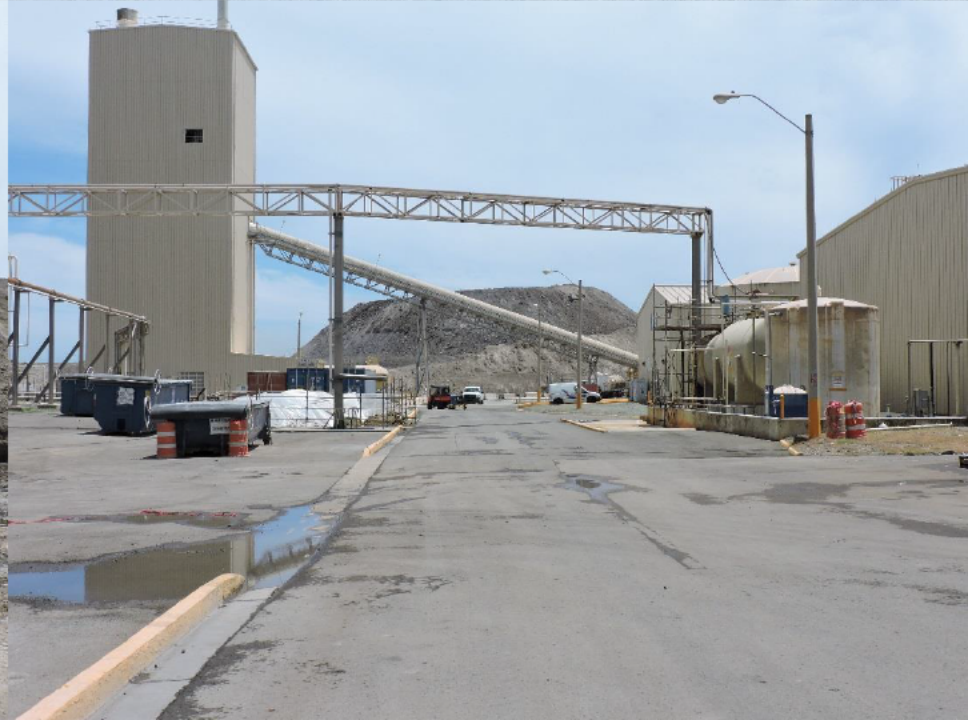
- August 2016 – Enforcement Case Support Inspection
 - Submittal of Pending Reports (e.g., annual reports) – done
 - SW Sampling SOP – done
 - SW Quarterly Monitoring and Reporting – ongoing
 - Final BMPs Implementation Report – done
 - Plan of Action
 - BMPs for pending areas – done
 - Plan for minimization and control of dust – submitted on time
 - Postponed submittal of comments due to Aggremax legal cases and increase in storage
 - Creation of SW Coordinator Position – done
 - Submittal of Compliance Progress Reports - ongoing

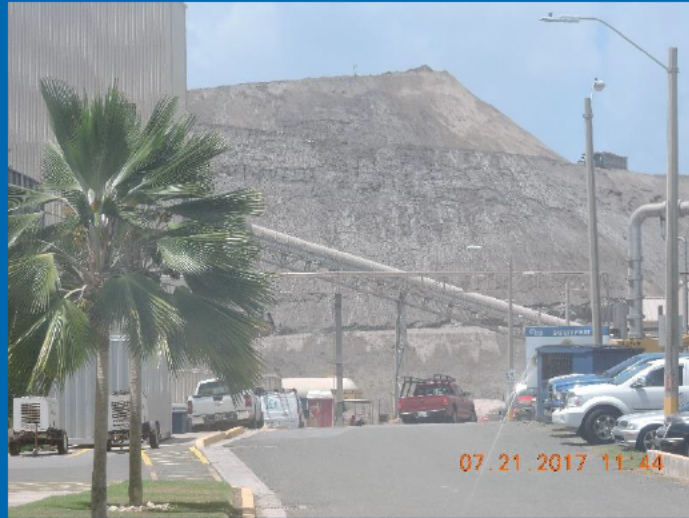
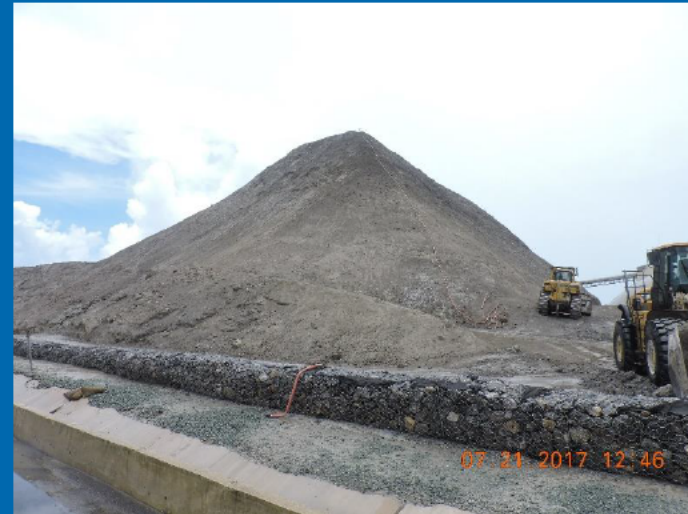
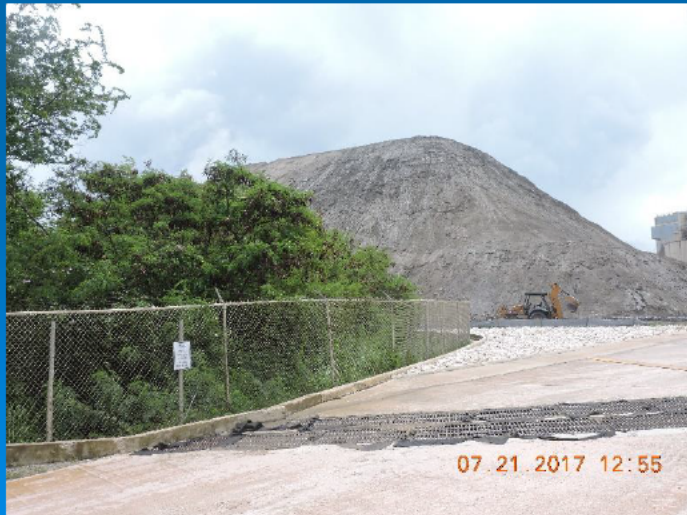
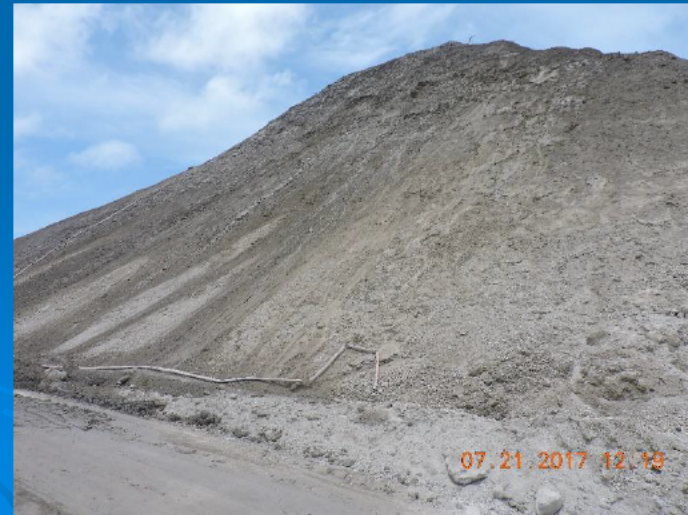
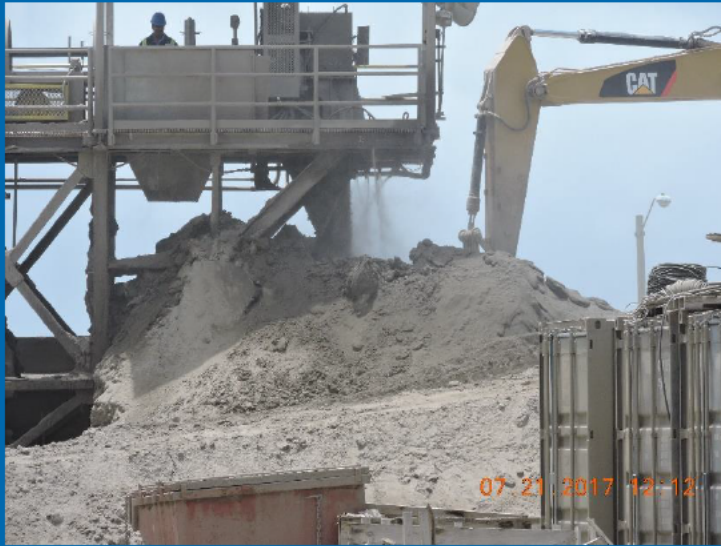
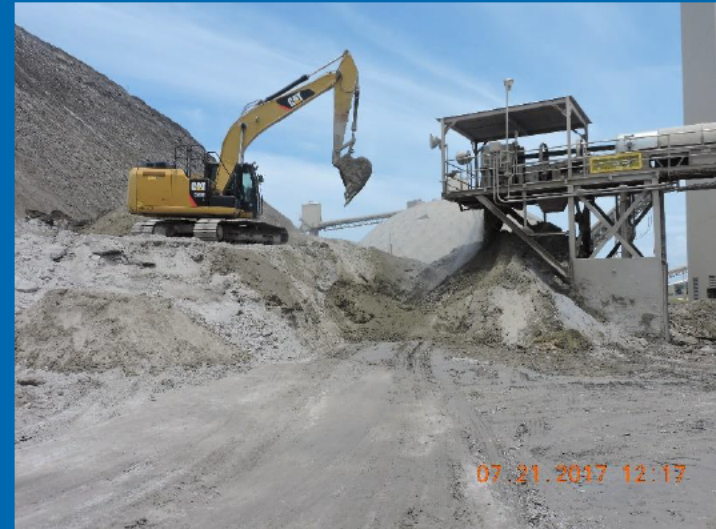
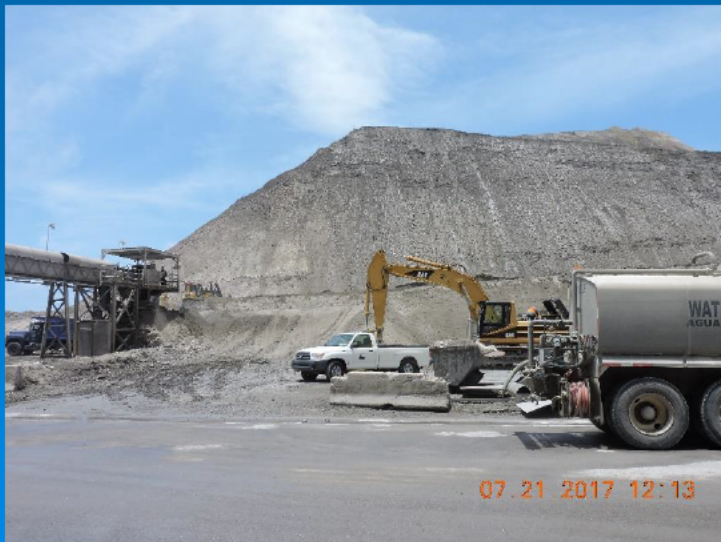
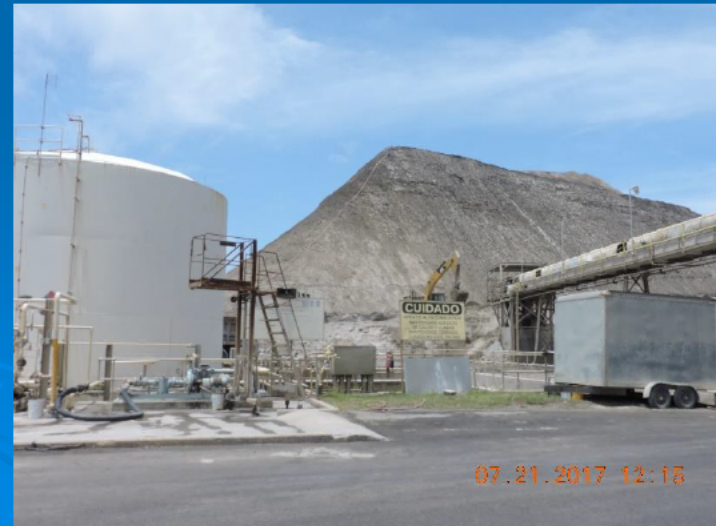
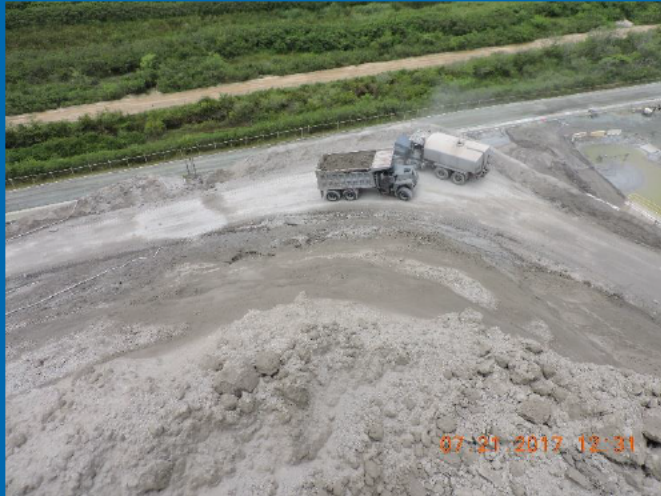
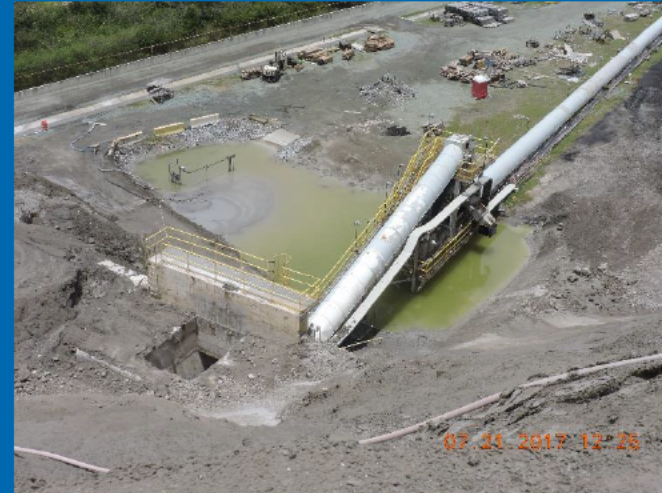
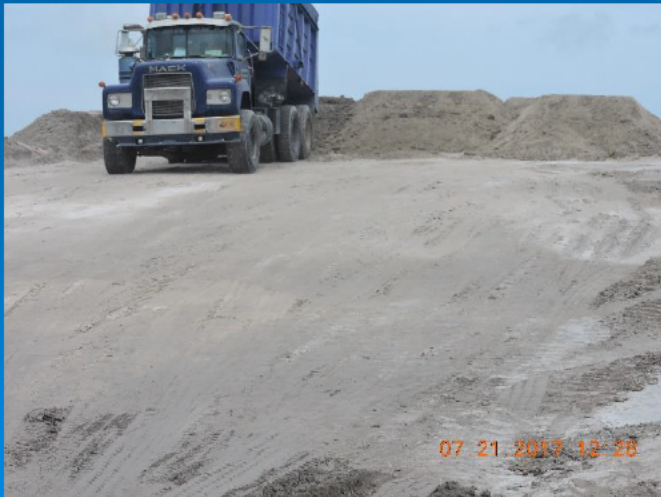
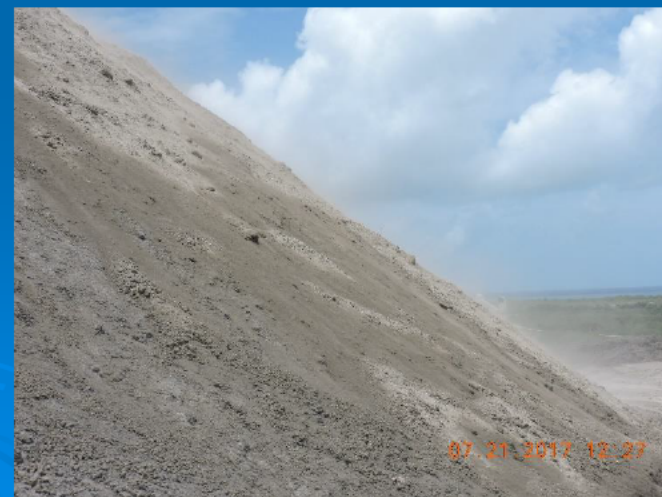
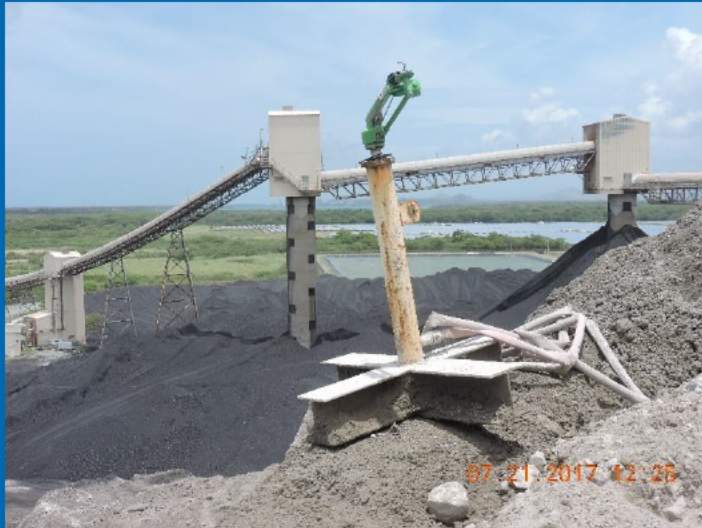
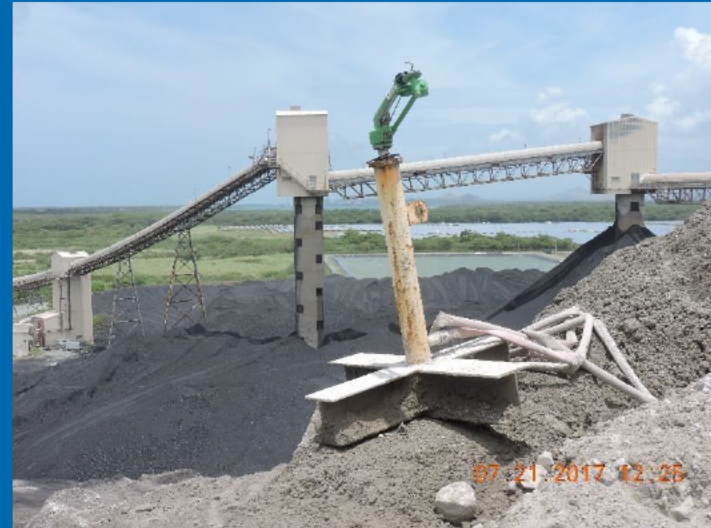
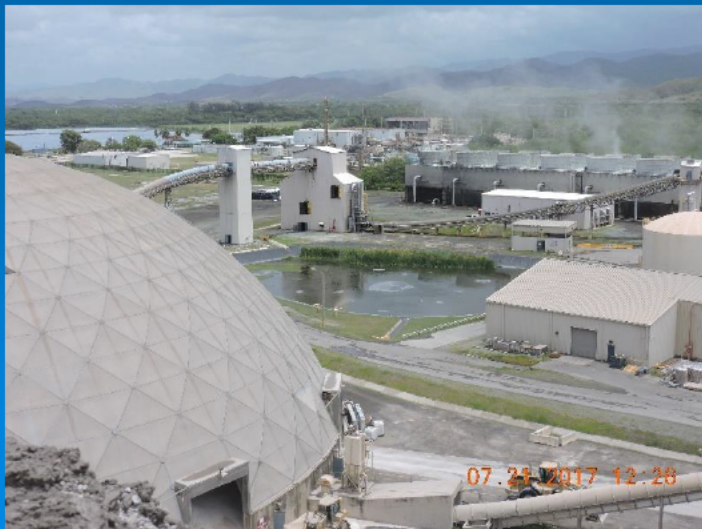
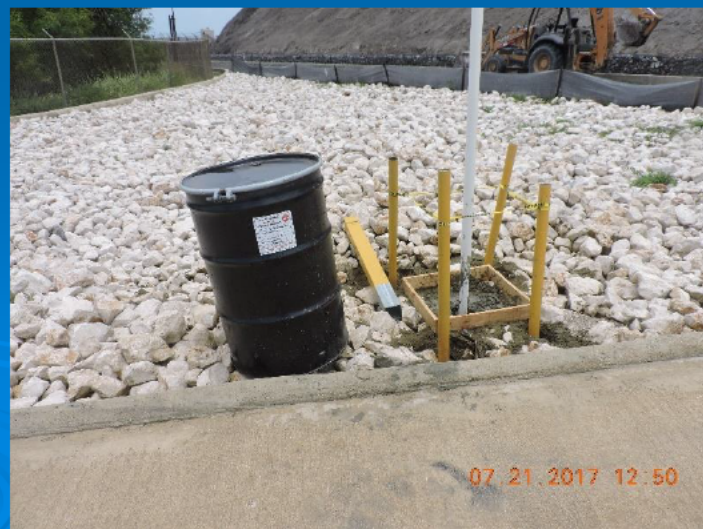
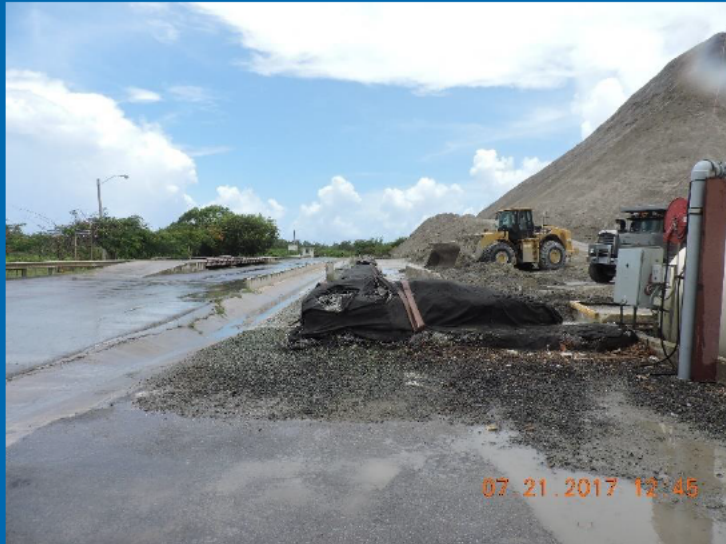
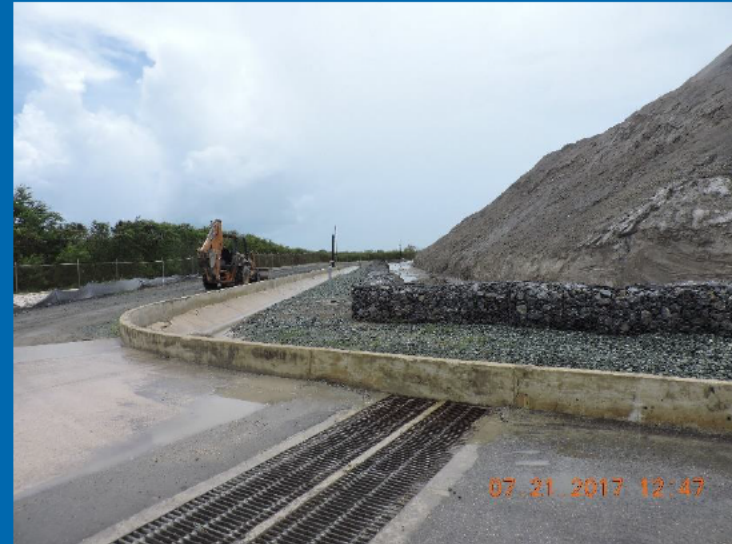
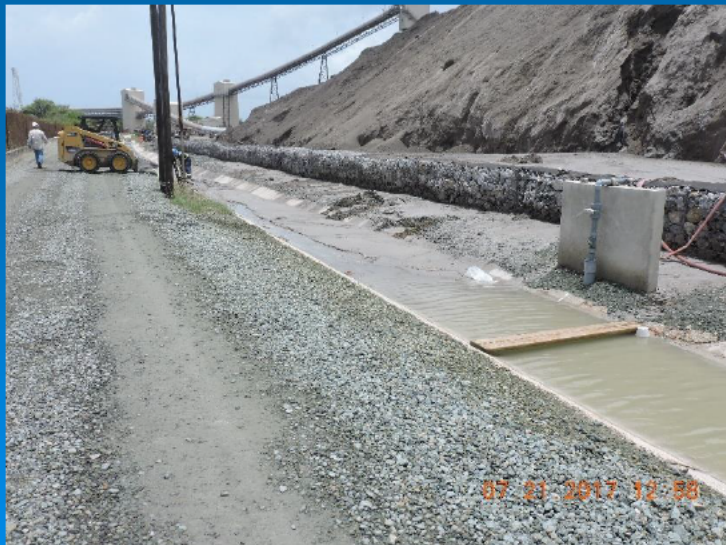
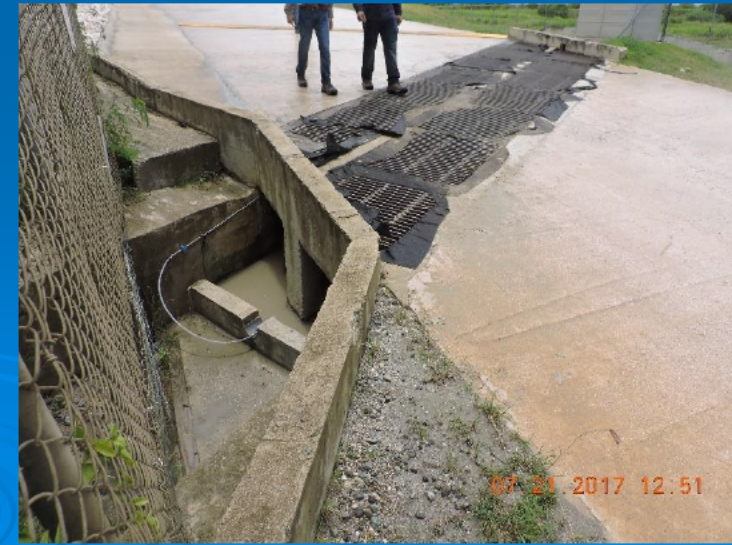
- Evaluate AES's response to the EPA's comments on the Dust Control Plan
- Evaluate potential BMPs to address Iron in Outfall 002
- Visit Sampling Points 002 and 003
- Evaluate the implementation of Dust Control in the Agremax Pile
- Note: The Site Visit did not include review of records
